**Flood Control Project Maintenance  
Levee Inspections**

**Maintenance Issue Types Only, Levee Inspection Report By Mile - Fall 2018**

**Sutter Maintenance Yard Maintenance Area 0007**

| Waterway | Bank | Unit Miles | Inspection Start/End | Inspector |
|---|---|---|---|---|
| Unit No. 01 Feather River | Right | 11.90 | 09/06/2018<br>09/06/2018 | Sterling<br>York |

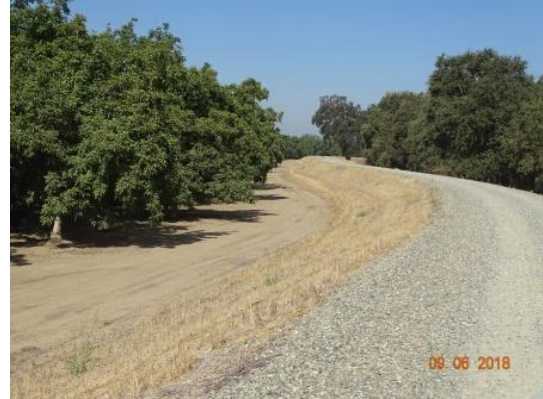
Photo 1 of 1 : FA\_2018\_MA0007\_200\_11\_20181002\_00026.jpg

| The annual vegetation is well maintained, Fall 2018. | | | | | |

View looking upstream landside at the well maintained vegetation, Fall 2018.

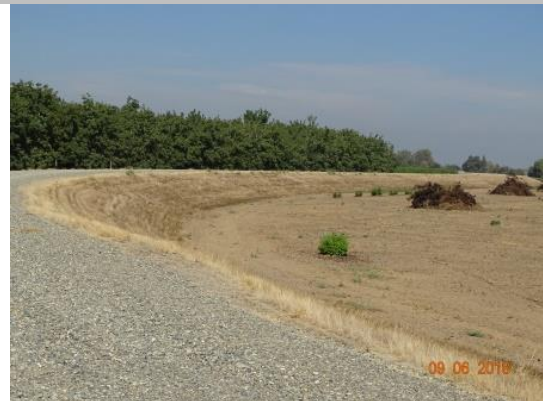
Photo 1 of 1 : FA\_2018\_MA0007\_200\_12\_20181002\_00027.jpg

| The annual vegetation is well maintained, Fall 2018. | | | | | |

View looking upstream waterside at the well maintained vegetation, Fall 2018.

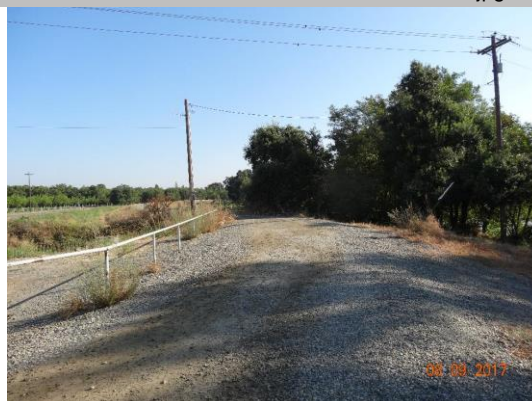
Photo 1 of 3 : UCIP\_FA\_2018\_52390\_77346.jpg

UCIP Comments: 08/09/2017 Dual 60-inch pipes are still present--no modifications appear to have been made to this structure. No permit or owner has been identified. Need to contact owner to notify of safety issue regarding the missing covers for CMP riser. (DWR UCIP - O. Magana)08/02/2017 After reviewing record drawings it appears this crossing has remained. Project Improvements begin at Station (Sta) 1765+00 (MA0007 about LM 1.73) to Sta 2303+50 (ST0005 about LM 1.23), refer to record drawings for the Feather River West Levee Improvement Plans Station 1765+00 to 2368+26, Project D details. MA0007 project details include NO CUTOFF WALL from Sta 1765+00 (MA0007 about LM 1.73) to 1815+00 (MA0007 about LM 2.64) and LEVEE DEGRADE AND RECONSTRUCTION WITH CUT OFF WALL from Sta 1817+00 (MA0007 about LM 2.69) to Sta 2289+00, Sta 2287+00 to Sta 2290+00 (MA0007 about LM 11.60). (DWR UCIP - O. Magana)

5/16/2016 Feather River West Levee Improvement Project--Levee currently under construction.6/10/2015 Debris still present in risers and pipes were not replaced with the SBFA project.12/29/2014 Same as last inspection.5/19/2014 Same as last inspection.11/6/2013 Same as last inspection.5/13/2013 SBFA project recommends replacing in accordance with title 23.5/7/2013 Same debris issue as last inspection. Recommend repairing top cover to prevent falls. Wheel to open gate chained and locked so could not verify gate operation.10/31/2012 Debris inside riser could prevent slide gate from closing. This crossing was listed in the USACE Periodic Inspections as ID# USACE\_CESPK\_MA07\_2010\_a\_0060 however, no issues noted. (DWR UCIP - O. Magana)

Overview of levee crown looking upstream towards crossings.

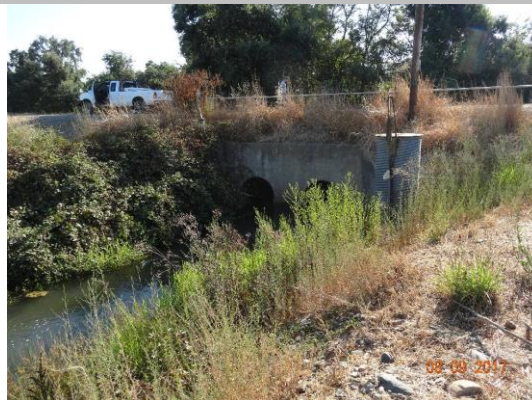
Photo 2 of 3 : UCIP\_FA\_2018\_52390\_77351.jpg

LS view: concrete headwall with dual 60-inch crossings visible from LS.

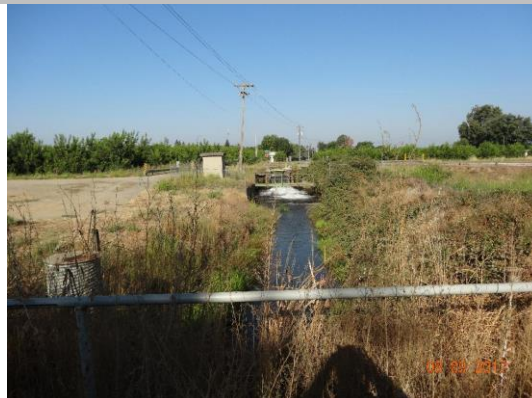
Photo 3 of 3 : UCIP\_FA\_2018\_52390\_77342.jpg

LS view: view of canal looking west from crossing.

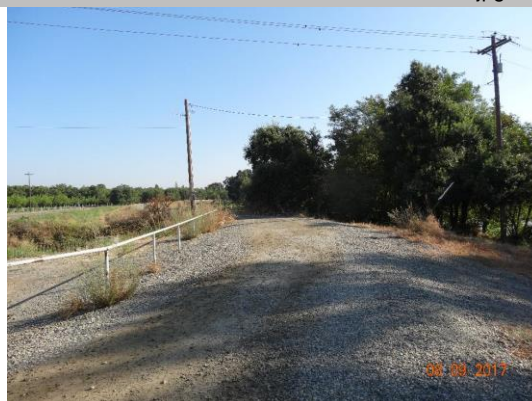
Photo 1 of 3 : UCIP\_FA\_2018\_52389\_77352.jpg

FS\_ID:52389  
DS\_ID:17011  
EP\_NO: N/A  
Repair Type: Non-Urgent  
Crossing Status: Found  
UCIP Comments: 08/09/2017 Dual 60-inch pipes are still present--no modifications appear to have been made to this structure. No permit or owner has been identified. Need to contact owner to notify of safety issue regarding the missing covers for CMP riser. (DWR UCIP - O. Magana)08/02/2017 After reviewing record drawings it appears this crossing has remained. Project Improvements begin at Station (Sta) 1765+00 (MA0007 about LM 1.73) to Sta 2303+50 (ST0005 about LM 1.23), refer to record drawings for the Feather River West Levee Improvement Plans Station 1765+00 to 2368+26, Project D details. MA0007 project details include NO CUTOFF WALL from Sta 1765+00 (MA0007 about LM 1.73) to 1815+00 (MA0007 about LM 2.64) and LEVEE DEGRADE AND RECONSTRUCTION WITH CUT OFF WALL from Sta 1817+00 (MA0007 about LM 2.69) to Sta 2289+00, Sta 2287+00 to Sta 2290+00 (MA0007 about LM 11.60). (DWR UCIP - O. Magana)

5/16/2016 Feather River West Levee Improvement Project--Levee currently under construction.6/10/2015 Debris still present inside riser and pipe was not replaced with the SBFCA project.12/29/2014 Same as last inspection.5/19/2014 Same as last inspection.11/6/2013 Same as last inspection.5/13/2013 SBFCA project recommends replacing in accordance with title 23.5/7/2013 Same as last inspection. Recommend constructing cover to prevent falls. Wheel to operate gate chained and locked so gate operation could not be verified.10/31/2012 no cover; debris inside riser could prevent slide gate from closing. This crossing was listed in the USACE Periodic Inspections as ID# USACE\_CESPK\_MA07\_2010\_a\_0060 however, no issues noted. (DWR UCIP - O. Magana)  
FIELD\_STRUCT\_DESC: 2 of 2: 60-inch corrugated metal gravity drainage pipe through the levee, 12.5 feet below the crown. Slide gate in a 78-inch corrugated metal pipe (CMP) well on the waterside (WS) slope. Concrete bulkheads on both ends. Reinforced concrete spillway on the WS end. (Existing 60-inch corrugated metal gravity drainage pipe crossing remained during the Feather River West Levee Improvements, Project D). [Additional Reference(s): DWR Levee Log, 2005. USACE Sacramento O&M Manual 152, March 1957 (Station 1+90). Sutter Butte Flood Control Agency (SBFCA) Feather River West Levee Project, Volume 4 of 6 (Project D) Feather River West Levee Improvement Plans Sta 1765+00 to 2368+26, 2016, Volume 4-SBFCA\_Record\_Drawings\_Project D\_2017.05.16.pdf, Drawing No. C-101].

Overview of levee crown looking upstream towards crossings.

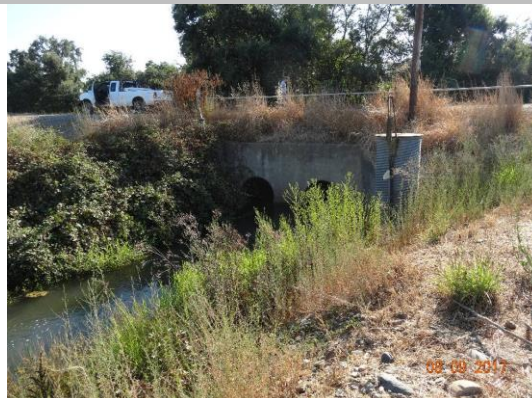
Photo 2 of 3 : UCIP\_FA\_2018\_52389\_77357.jpg

LS view: concrete headwall with dual 60-inch crossings.

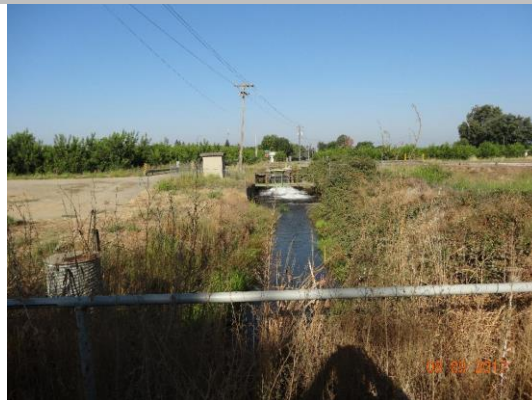
Photo 3 of 3 : UCIP\_FA\_2018\_52389\_77358.jpg

LS view: canal located on LS, photo taken from levee crown looking west.
